Manhole Inspection Summary

Manhole # S71E__002MH

Insp Date: **5/19/08 10:22 AM**

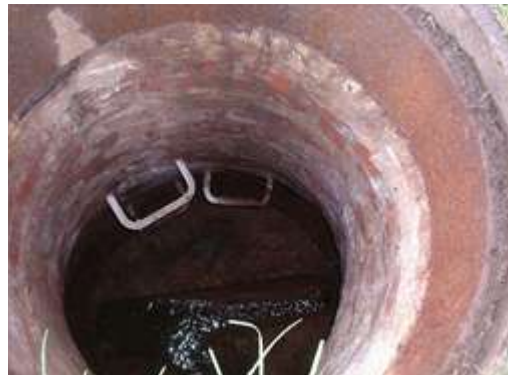
Defect 1

Infiltration

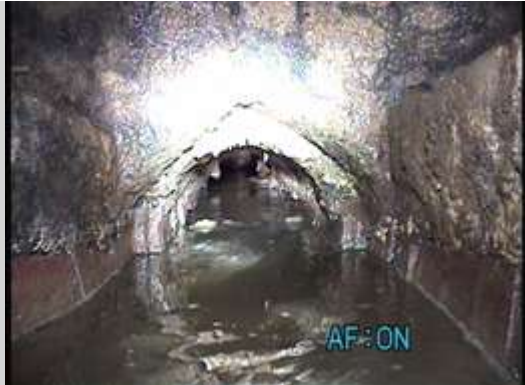
12 O'Clock Outflow

10 in. Circular Gravity Sewer
Pipe Out @ 12 O'Clock

Pipe Height: **10.8** (in.) Rod and Bar (Angled)
Pipe Material: **Clay** ☐ Pipe Lined
Invert Depth: **9.30** (ft.) Flow Characteristics: **Fast**
Deposits: ☒ None ☐ Mud ☐ Sludge ☐ Debris ☐ Grease
Silt Depth: (in.) Deposits Extent:
Infiltration: **None** Pipe Seal Cond: **Sound**

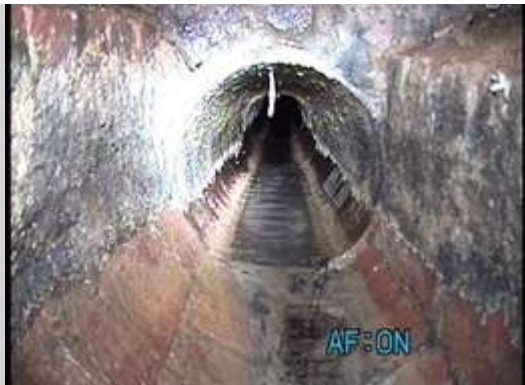
6 O'Clock Inflow

8 in. Circular Gravity Sewer
Pipe In @ 6 O'Clock

Pipe Height: **8.4** (in.) Rod and Bar (Angled)
Pipe Material: **Clay** ☐ Pipe Lined
Invert Depth: **8.80** (ft.) Flow Characteristics: **Fast**
Deposits: ☒ None ☐ Mud ☐ Sludge ☐ Debris ☐ Grease
Silt Depth: (in.) Deposits Extent:
Infiltration: **None** Pipe Seal Cond: **Sound**

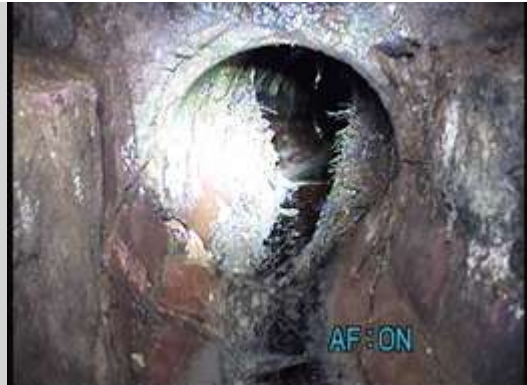
9 O'Clock Inflow

8 in. Circular Gravity Sewer

Pipe In @ 9 O'Clock

Infiltration: **None** Pipe Seal Cond: **Sound**
